Gold Crest Chartered Surveyors

Building Survey [Example]

Property address: Example
Property postcode: Example
Client's name: Example
Date of inspection: Example
Reference number: Example

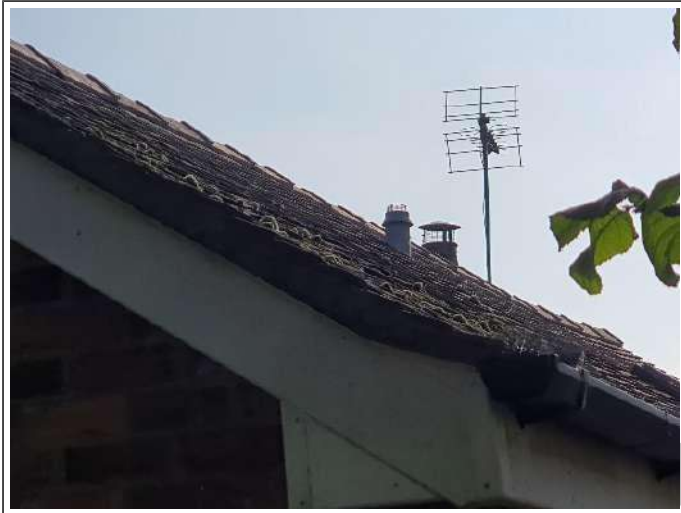
RIGHT

CHIMNEY DESCRIPTION: There is a gas flue terminal.

CONDITION SUMMARY: No significant defects were apparent. Faulty/blocked flues can however cause lethal gases to build up within the home. The flue should be tested by the Engineer recommended later on within this report under the heading of Gas.

CONDITION RATING: Defects that are serious and/or need to be repaired, replaced or investigated urgently.

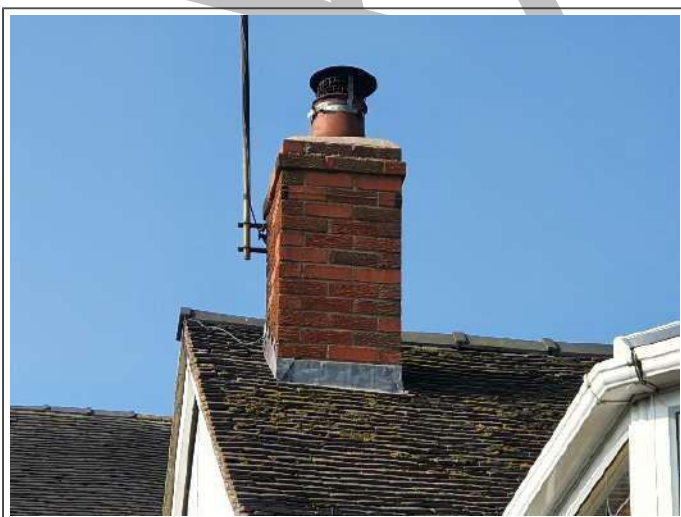
LEFT

CHIMNEY DESCRIPTION: There is brickwork to the single flue chimney(s).

CONDITION SUMMARY: No significant defects were apparent. The chimney however appears to have been reconstructed recently. This should have been carried out with Building Regulation approval and the flue should have been tested by a HETAS registered engineer. Your legal advisor should confirm that the correct documentation is available. If Building Regulation approval has not been obtained, you could discuss indemnity insurance with your legal advisor to cover you against any enforcement action in the future. It is however important that the flue has been tested recently and this should be done before using the fire if no recent certificate is available.

CONDITION RATING: Defects that are serious and/or need to be repaired, replaced or investigated urgently.

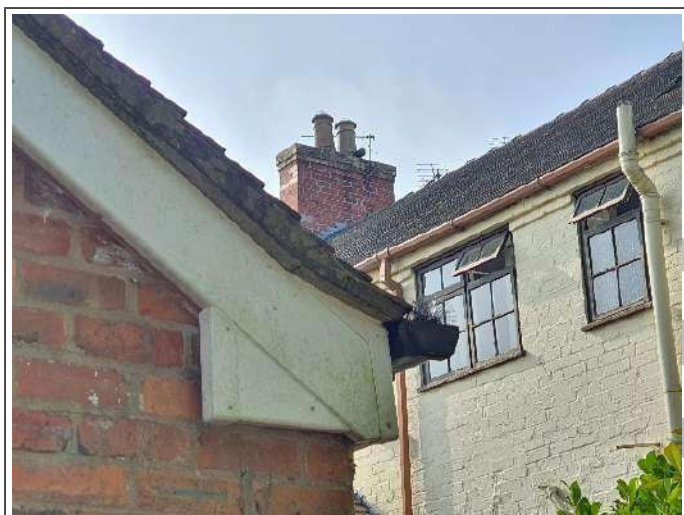
FRONT

CONDITION SUMMARY: The cement verge to the gable end will require some re-pointing soon. The old cement should be chopped out and replaced to help prevent rainwater penetration internally and rot to the roofing timbers. The under-cloaking appears to be of asbestos cement and therefore any work to this part of the property should be carried out by a contractor who is qualified in asbestos awareness.

CONDITION RATING: Defects that need repairing or replacing but are not considered to be either serious or urgent. The property must be maintained in the normal way.

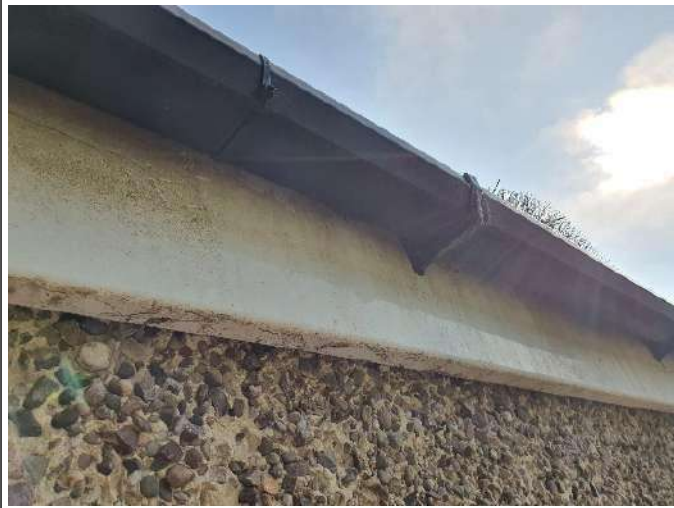
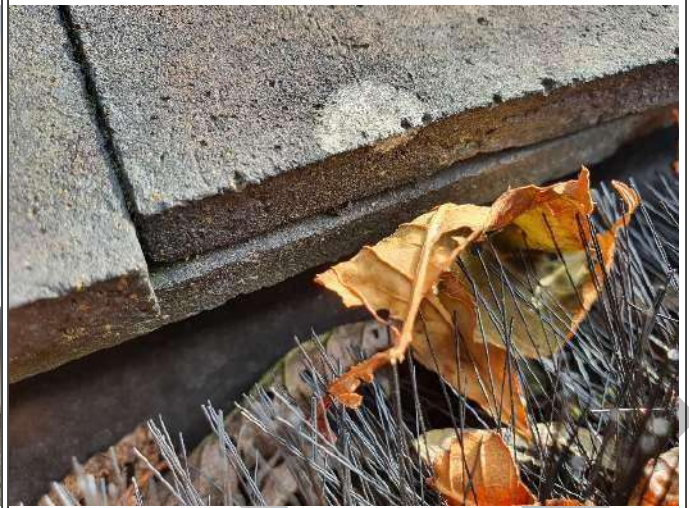
RIGHT

CONDITION SUMMARY: There are stains on the fascia boards. There is no felt leading into the gutter from underneath the roof tiles. In worst cases, the timber battens and other components of the roof that are not visible can be affected by consequent rot and this may only be found by removing some of the roof tiles. It is therefore recommended that some of the roof tiles are removed by an appropriately qualified person so that the hidden components can be seen, and the likely cost of any necessary repair work can be quantified. Felt can contain asbestos and therefore any work to the roof should be carried out by a contractor that is qualified in asbestos awareness.

CONDITION RATING: Defects that are serious and/or need to be repaired, replaced or investigated urgently.

ASSUMED REPAIR COST: £1000

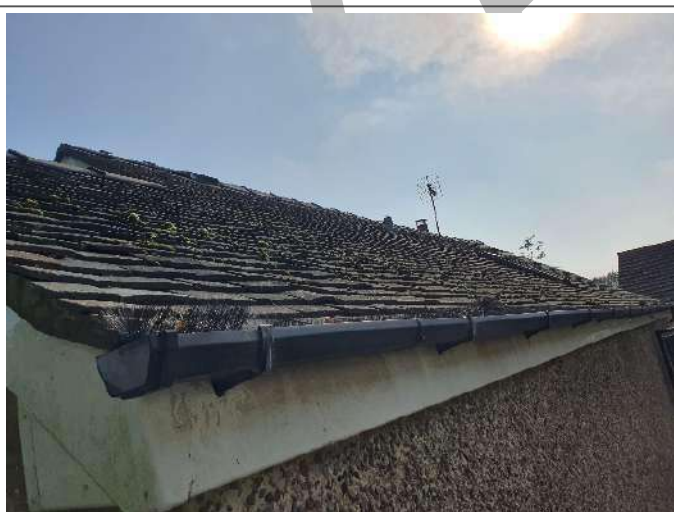
RIGHT

CONDITION SUMMARY: The roof covering is slightly vegetated with moss. This needs to be cleaned off occasionally to prevent it from accumulating and then falling into the rainwater gutters, causing blockages to occur, as well as affecting the aesthetic appearance of the building. This work should not be necessary more often than approximately every 10 years or so. There is some deflection to the roof covering and this is not unusual for property this age. You should however monitor the roof for signs of further movement in the future as further support may be needed. If further movement is noted, a specification should be drawn up by a Structural Engineer for a Joinery Contractor to work to.

CONDITION RATING: Defects that need repairing or replacing but are not considered to be either serious or urgent. The property must be maintained in the normal way.

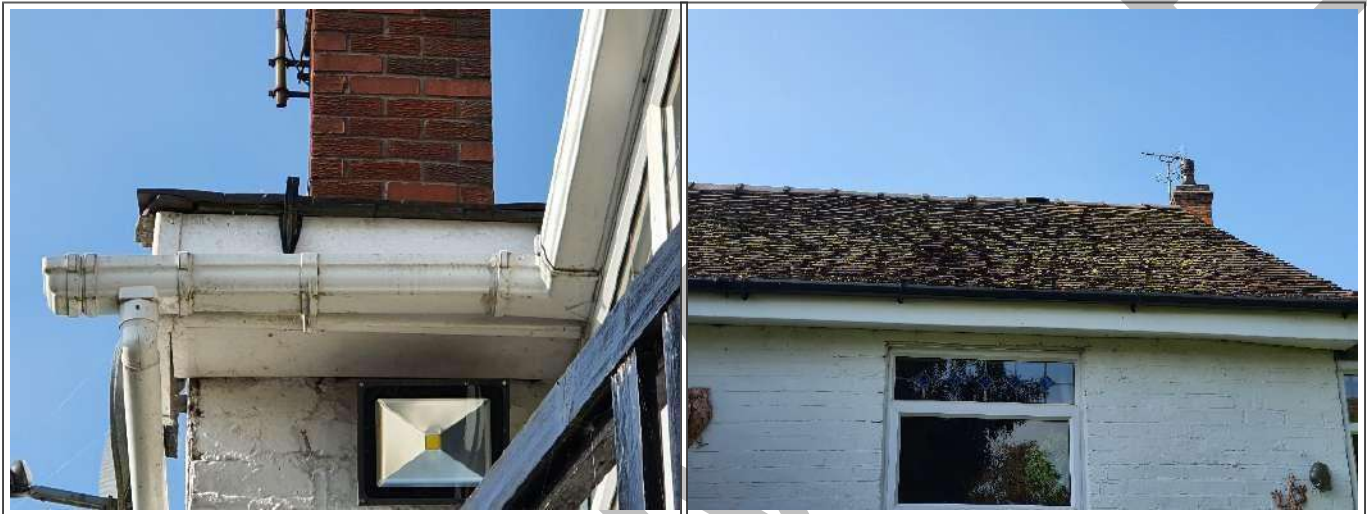
LEFT

CONDITION SUMMARY: The roof covering is significantly vegetated with moss. This needs to be cleaned off soon. This should not be necessary more often than approximately every 10 years or so. As mentioned above, an eaves tray should be installed along the length of the roof covering to help prevent rainwater ingress.

There is a loose tile to the back corner of the building that requires refitting to help prevent rainwater ingress and rot to roofing timbers.

CONDITION RATING: Defects that need repairing or replacing but are not considered to be either serious or urgent. The property must be maintained in the normal way.

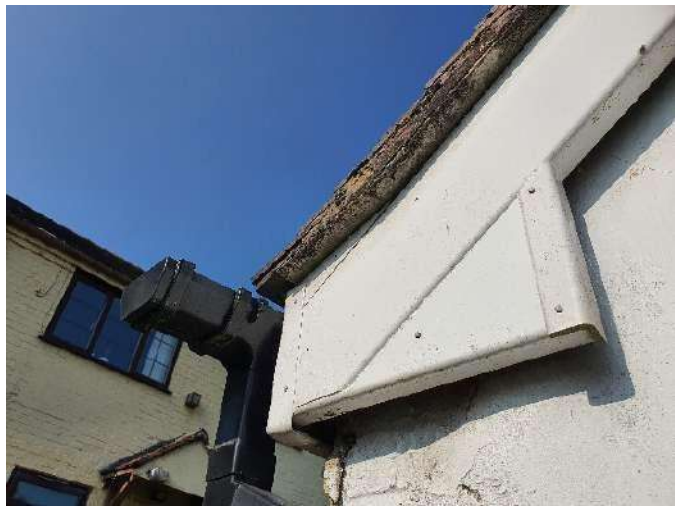
REAR

CONDITION SUMMARY: The condition of this part of the property is similar to the front elevation, with the cement verge requiring some repointing soon. The undercloaking could be of asbestos cement here too.

CONDITION RATING: Defects that need repairing or replacing but are not considered to be either serious or urgent. The property must be maintained in the normal way.

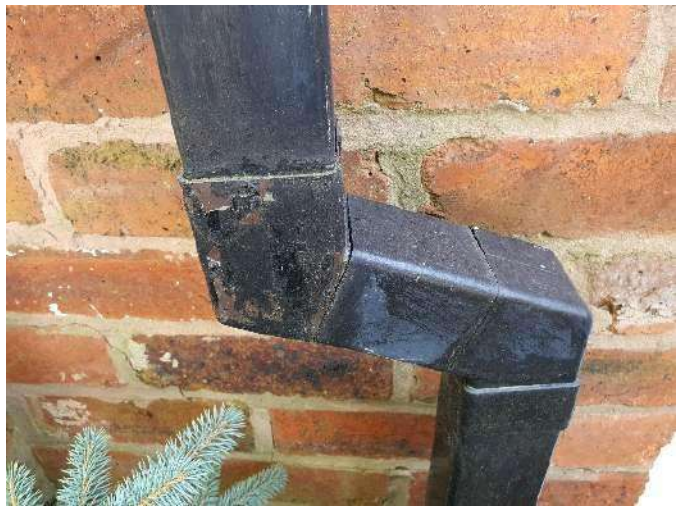
FRONT

CONDITION SUMMARY: The rainwater fittings appear to have been painted. PVC is not meant to be painted in this way and this will be unsightly as the paint begins to peel. Some potential purchasers would therefore wish to have the rainwater fittings replaced.

CONDITION RATING: Defects that need repairing or replacing but are not considered to be either serious or urgent. The property must be maintained in the normal way.

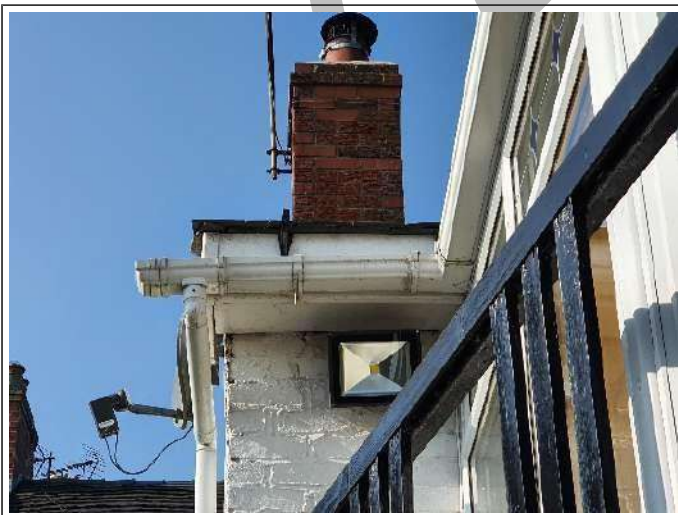
LEFT

CONDITION SUMMARY: The rainwater fittings are too low to the rear corner of the building. It is recommended that the gutter is reinstated above, and a small downpipe is fitted. This should be done so that the rainwater reaches the downpipe to help prevent damage to the joinery and roof timbers. This work should be carried out by a reputable roofing contractor as soon as possible.

CONDITION RATING: Defects that are serious and/or need to be repaired, replaced or investigated urgently.

ASSUMED REPAIR COST: £250

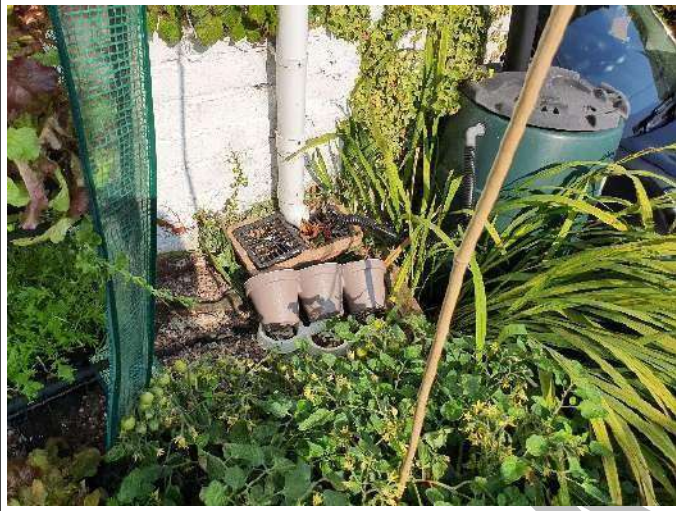
REAR

CONDITION SUMMARY: The drainage gully is not set into the ground and could be vulnerable to damage. We recommend that this is rectified by a reputable drainage contractor.

CONDITION RATING: Defects that need repairing or replacing but are not considered to be either serious or urgent. The property must be maintained in the normal way.

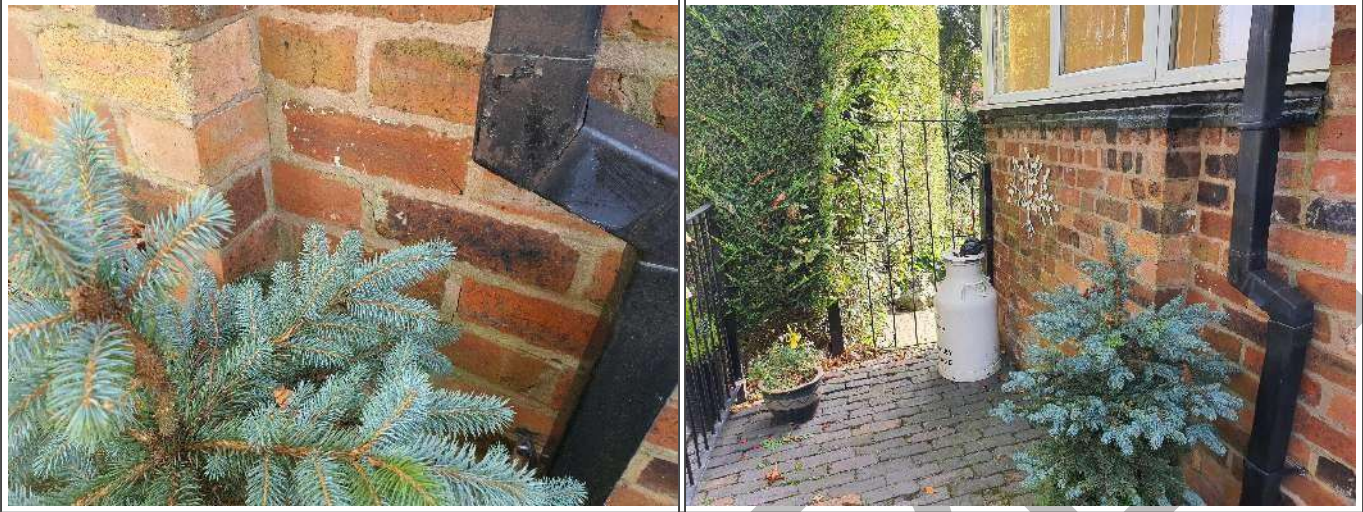
FRONT

CONDITION SUMMARY: There is cracking to the side of the bay that is likely to be caused by the tree(s)/bushes to the front/side. Non-mature trees should not be allowed to grow any taller than their distance from the property to help protect the foundations. Trees remove extra water from the ground as they grow, which can sometimes destabilise the ground beneath the foundations and this can then cause movement and/or affect drainage. We recommend that the trees/bushes are maintained by an Arboriculturist. The cracking should be raked out and repointed with a lime mortar and not cement should be used to allow the brickwork to breathe. The drainage should also be tested by a drainage specialist to ensure there are no defective drains causing movement. Given the age of the property, we recommend that the whole drainage system is tested. Due to the age of the property, it could be the local water company that is responsible for any drainage repairs and this should be confirmed by your legal advisors. If the cracks open up again after the trees are maintained and any possible drainage repairs, further advice should be obtained from a Structural Engineer.

CONDITION RATING: Defects that are serious and/or need to be repaired, replaced or investigated urgently.

ASSUMED REPAIR COST: £1500

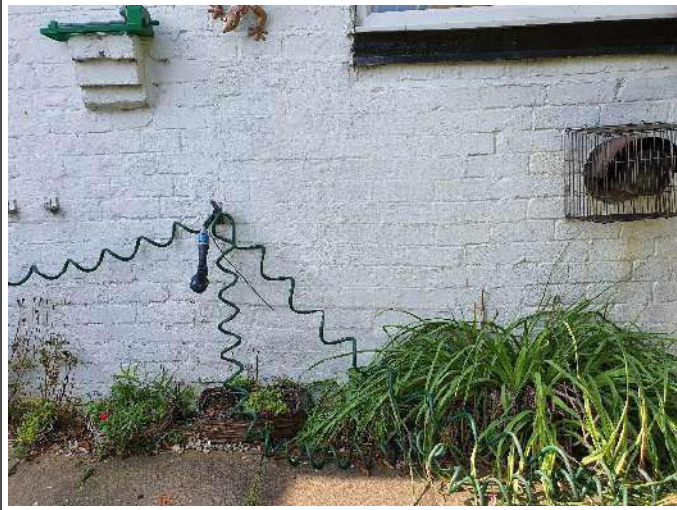
LEFT

CONDITION SUMMARY: Some distortion was noted to the left elevation. Much of the distortion could be attributed to alterations that have been made to the building in the past, not all have been done to a professional standard. There does not appear to be any signs of any recent movement, but as mentioned above, the trees to the front of the building could continue to cause some movement if left a grow and they should be maintained by a qualified Arboriculturist. As there have been several alterations to the building that of a substandard nature, there is an elevated risk of latent defects occurring. Building Regulation approval should have been obtained and it is clear that it has not. You should monitor this wall for signs of movement and obtain further advice from structural engineer if any occurs.

CONDITION RATING: Defects that need repairing or replacing but are not considered to be either serious or urgent. The property must be maintained in the normal way.

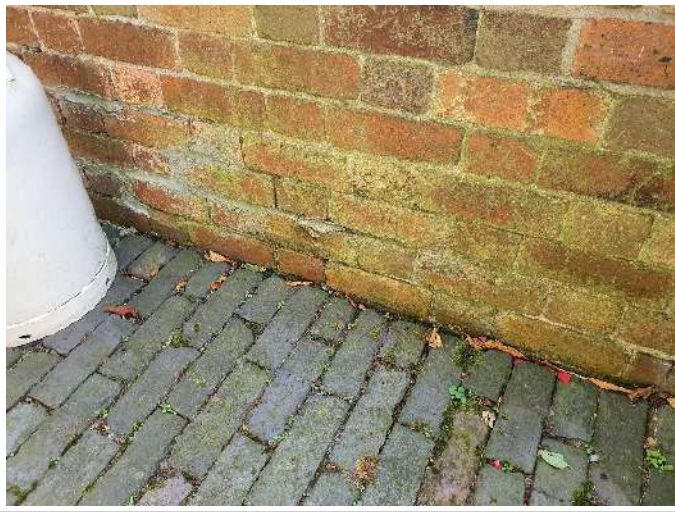
FRONT

CONDITION SUMMARY: We observed small areas of open-jointed masonry. Mortar joints open up as a result of erosion by rainwater and once the joints become open, they become more porous. It is therefore recommended that open joints are raked out to a depth of twice the width of the joint and then repointed with lime-based mortar. Lime-based mortar should be used as this allows the masonry to breathe and any moisture to escape.

CONDITION RATING: Defects that need repairing or replacing but are not considered to be either serious or urgent. The property must be maintained in the normal way.

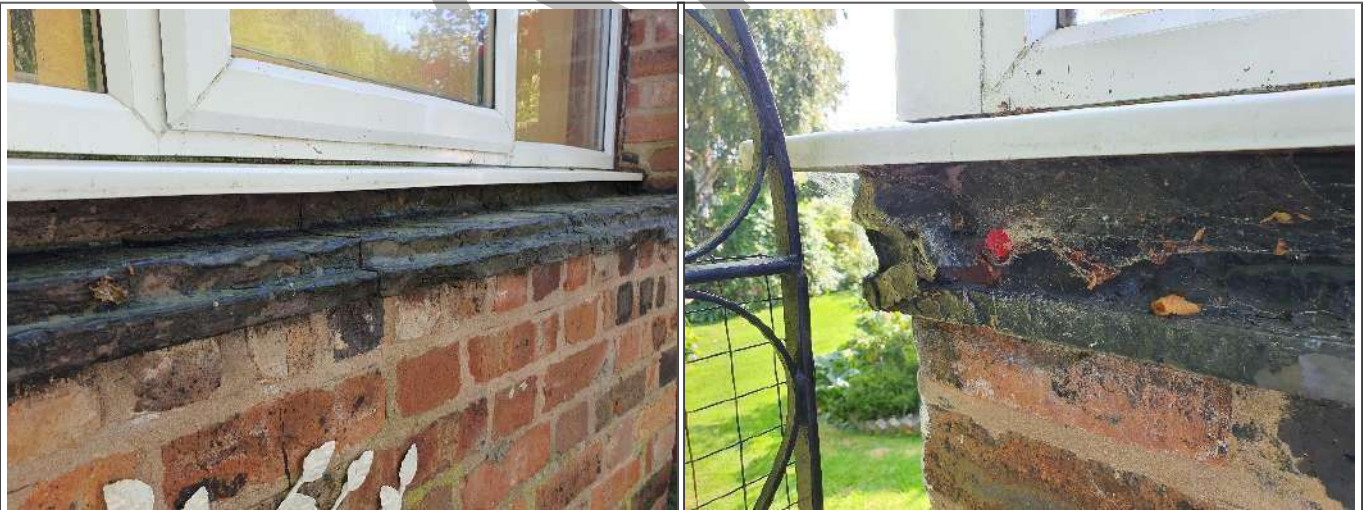
FRONT

CONDITION SUMMARY: There appears to be impervious masonry paint to the porch sill. The paint is blistering in places. This appears to be a type of flashband material that has been painted. The flashband is slightly damaged. the flashband requires repairing by a reputable building contractor. A more suitable material for this purpose would be lead as it is much more durable.

CONDITION RATING: Defects that need repairing or replacing but are not considered to be either serious

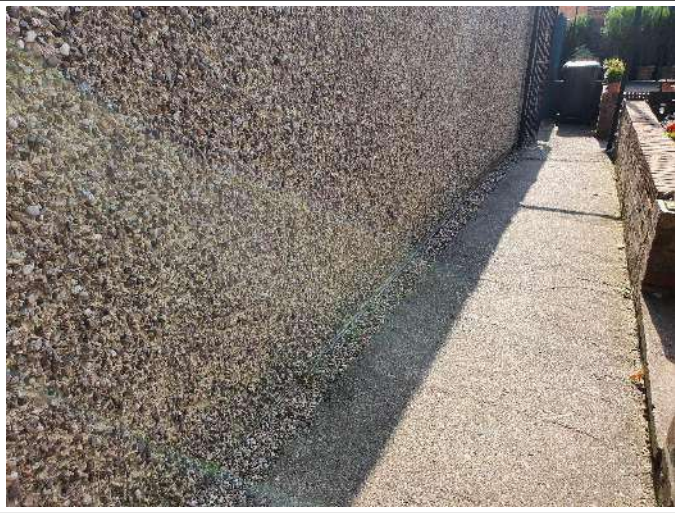
RIGHT

CONDITION SUMMARY: We should mention that cement render on solid brick walls is not ideal as it can lock in moisture and damage the brickwork beneath. Ideally, the render should be removed from the solid brick walls. At the very least, all cracks found in the render should be sealed as and when they occur to minimise the risk of damage. The render is touching the floor towards the front half of the building and this could cause dampness internally. You should have the render removed from the first two courses of bricks and a suitable drip bead installed along the whole length of the wall to help water fall away.

CONDITION RATING: Defects that are serious and/or need to be repaired, replaced or investigated urgently.

ASSUMED REPAIR COST: £500

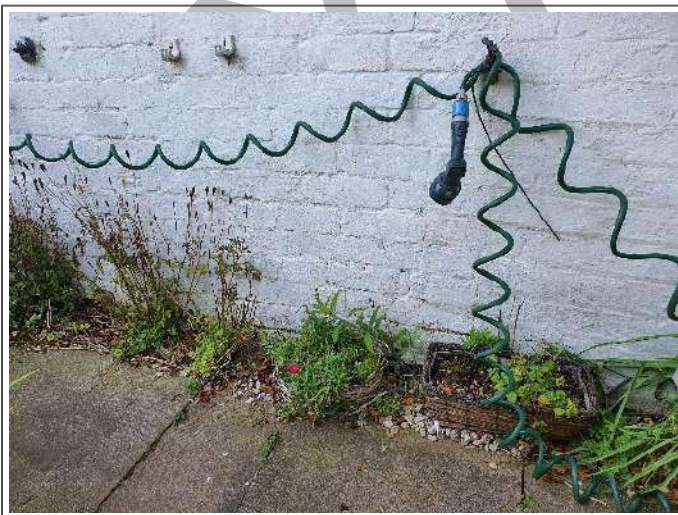
LEFT

CONDITION SUMMARY: There appears to be impervious masonry paint to the side and rear elevations.

The paint is blistering in places. This type of paint can help to cause damage to the wall and dampness internally. We therefore recommend that the paint is removed. However, sandblasting should be avoided as this can help to cause surface damage to the masonry, increasing the rate at which it deteriorates.

CONDITION RATING: Defects that are serious and/or need to be repaired, replaced or investigated urgently.

ASSUMED REPAIR COST: £500

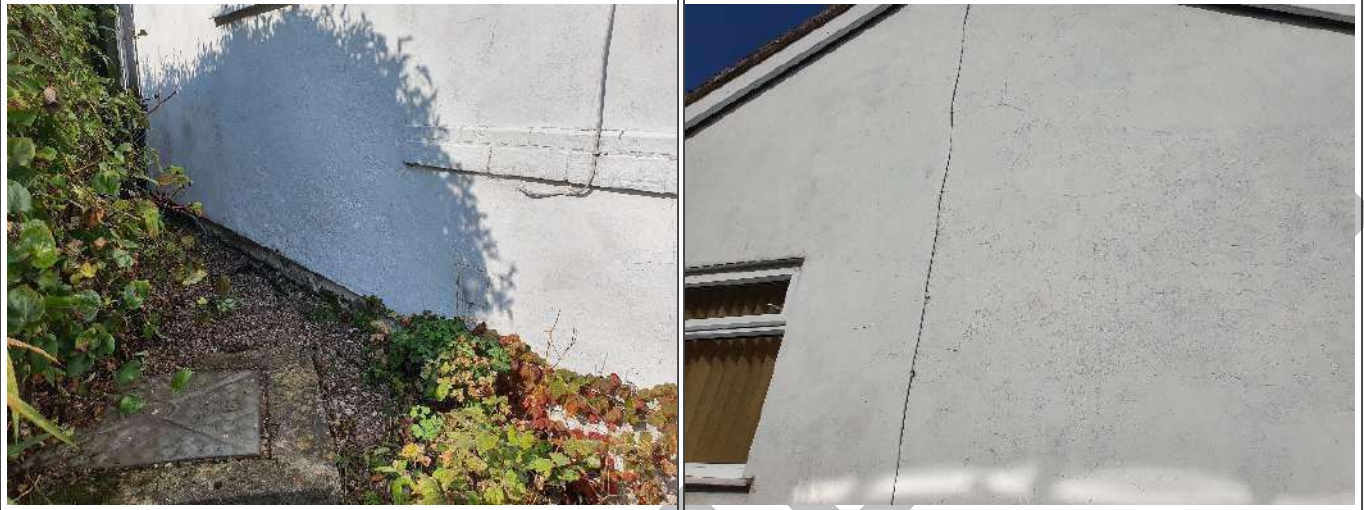
REAR

CONDITION SUMMARY: The render is damaged to the rear and some dampness was noted trapped behind the base of the render. The render should therefore be removed from the walls. However, this is likely to cause damage and any significantly damaged bricks should be replaced. If re-rendering is desired, due to damage caused by its removal, then this should be carried out with a lime render, using a breathable pigment or lime wash for a decorative finish. A suitable drip-bead should be installed to allow rainwater to drip away from the wall, as water can easily track back up behind the surface and become trapped, leading to dampness and damage. You should search the Federation of Master Builders register, which is available online, for contractors who have experience with lime building products. In the very least, all cracks found in the render should be sealed as and when they occur to minimise the risk of damage beneath.

CONDITION RATING: Defects that are serious and/or need to be repaired, replaced or investigated urgently.

ASSUMED REPAIR COST: £2000

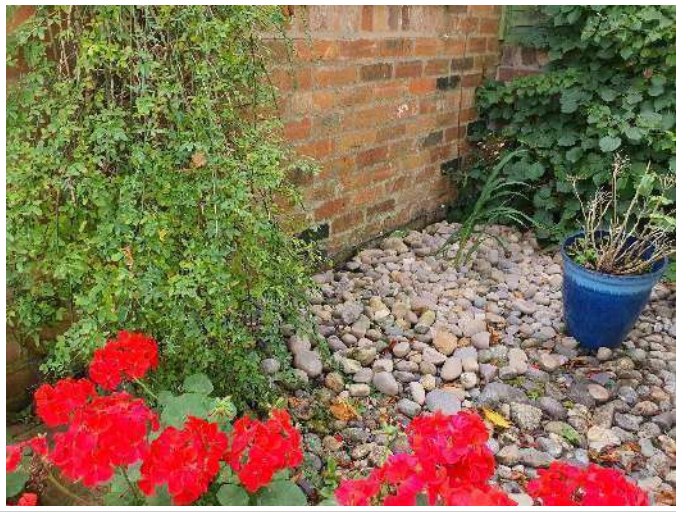
FRONT

CONDITION SUMMARY: Any damp proof course has been bridged by the raised garden to the front. Bridged DPC's can lead to dampness and rot to internal joinery. If dampness occurs internally you may need to have the wall tanked externally with a bitumen damp-proofing system. This work should be carried out via PCA registered damp proofing contractor and be covered with an insurance backed guarantee.

CONDITION RATING: No repair is currently needed. The property must be maintained in the normal way.

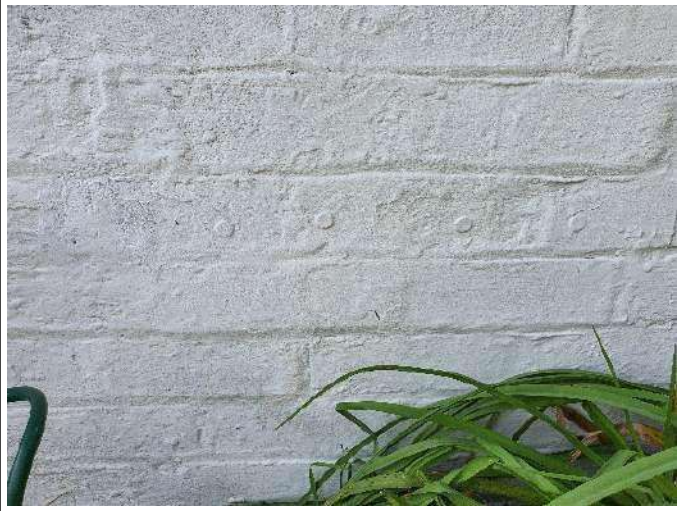
LEFT

CONDITION SUMMARY: There appears to have been a chemical injection DPC (damp proof course) injected into the walls retrospectively. This type of damp proofing can be ineffective. However, there is often a guarantee for this type of work and your legal advisers should confirm whether or not any documentation is available, which can be relied upon by yourselves.

CONDITION RATING: No repair is currently needed. The property must be maintained in the normal way.

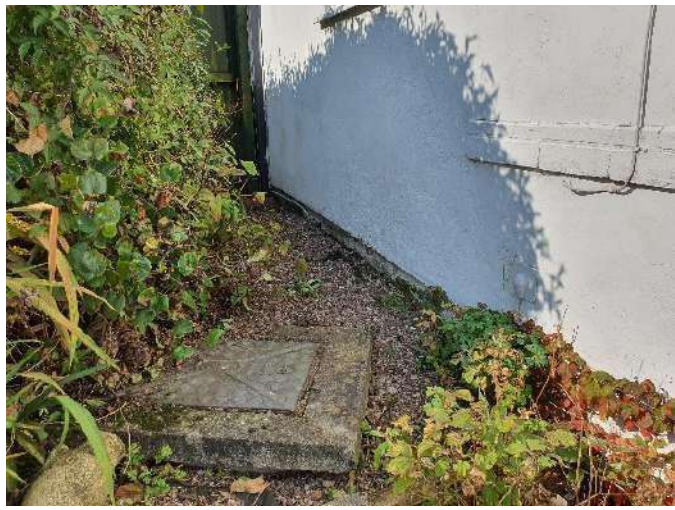
REAR

CONDITION SUMMARY: The damp proof course has been bridged by external ground towards the rear right-hand corner. Bridged DPC's can lead to dampness and rot to internal joinery. We therefore recommend that a ventilated box drain gully is installed at the base of the wall/s towards the rear corner if dampness does begin to occur internally.

CONDITION RATING: Defects that need repairing or replacing but are not considered to be either serious or urgent. The property must be maintained in the normal way.

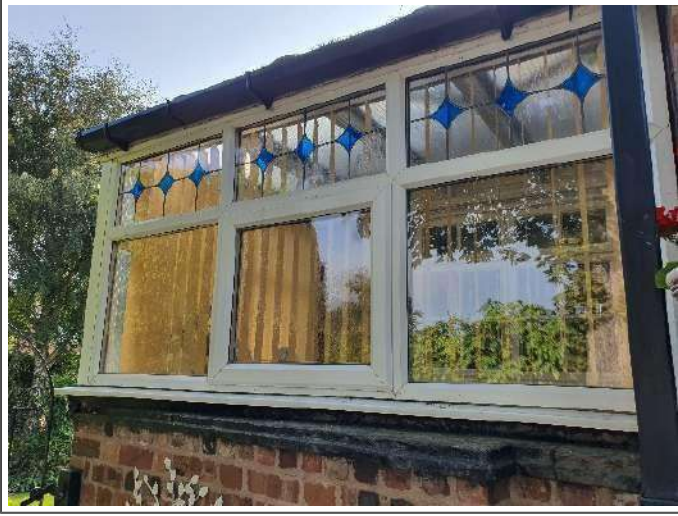
FRONT

CONDITION SUMMARY: We observed condensation appearing between panes of glass to the porch windows. Condensation could indicate an inherent issue with the glazing and other windows could soon become affected. An allowance should therefore be made for re-glazing when necessary.

CONDITION RATING: Defects that need repairing or replacing but are not considered to be either serious or urgent. The property must be maintained in the normal way.

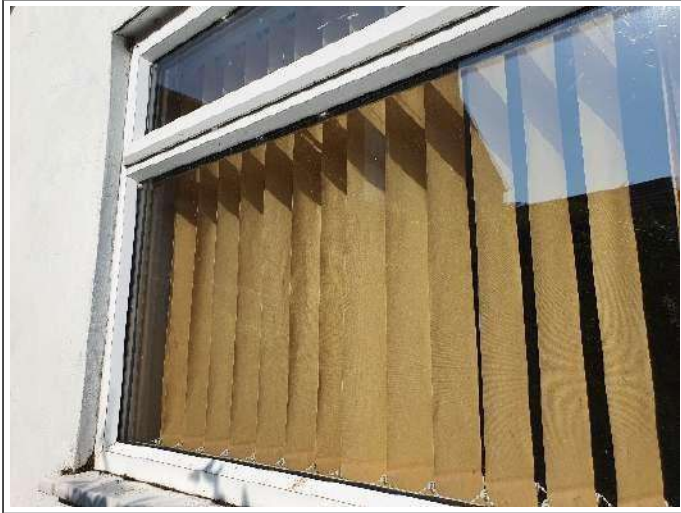
REAR

CONDITION SUMMARY: The window beads are on the outside of the windows, which could be easily removed and allow intruders to enter the property. You may therefore wish to have a window repair specialist check whether the windows are secure once the beads are removed and make any improvements if necessary.

CONDITION RATING: Defects that are serious and/or need to be repaired, replaced or investigated urgently.

ASSUMED REPAIR COST: £300

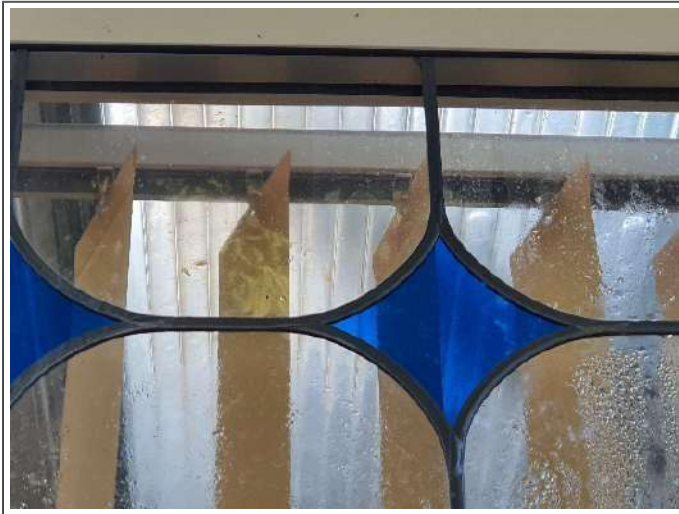
FRONT

CONDITION SUMMARY: At least two of the roof panels appear to have water within them and this will need repair by a conservatory stroke porch specialist.

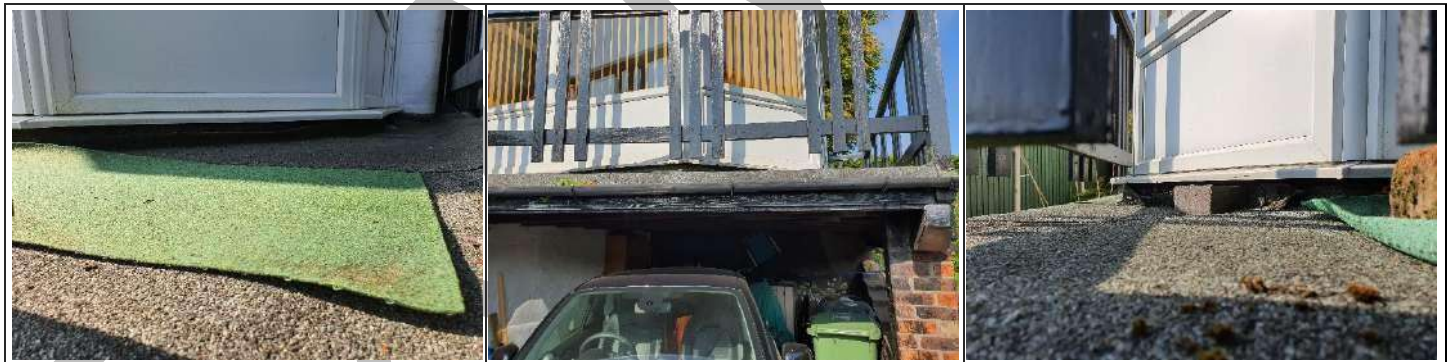
LEFT

CONDITION SUMMARY: The conservatory is situated on top of the car port. There do not appear to be any signs of stress to the carport and the roof of the car port appears reasonably substantial enough to take its weight. We have however assumed that structural calculations were carried out by an engineer and your legal advisor should check for this documentation. However, the car port roof is going to deteriorate over time and therefore maintenance of the supporting roof will be critical. Maintenance of the decking could be difficult in the future. You should therefore make sure that the felt covering is in good condition to help prevent rainwater seeping in and deteriorating the decking beneath. The felt is peeling away underneath the PVC frames and should be repaired by a reputable roofing contractor. You should also be vigilant for signs of deterioration to the carport roof's structural timbers and keep them well treated to help prevent rot and woodworm infestation. If there is a lack of documentation for the conservatory, there will be an increased risk of latent defects. We would say the biggest area of concern would be the potential for movement as the foundations of the carport are unlikely to be deep enough to take this type of loading. Therefore, if calculations have not been carried out, you should avoid using heavy furniture and refrain from entertaining a crowd of guests in the conservatory. You could have trail pits dug at the base of the walls for a Structural Engineer to check the foundation depth to ensure the carport is structurally adequate. You should be aware that this structure is likely to be a breach of Building Regulations. If the work was carried out over 10 years ago it is unlikely the local council will enforce action. However, future resale could be inhibited without documentation.

ASSUMED REPAIR COST: £500

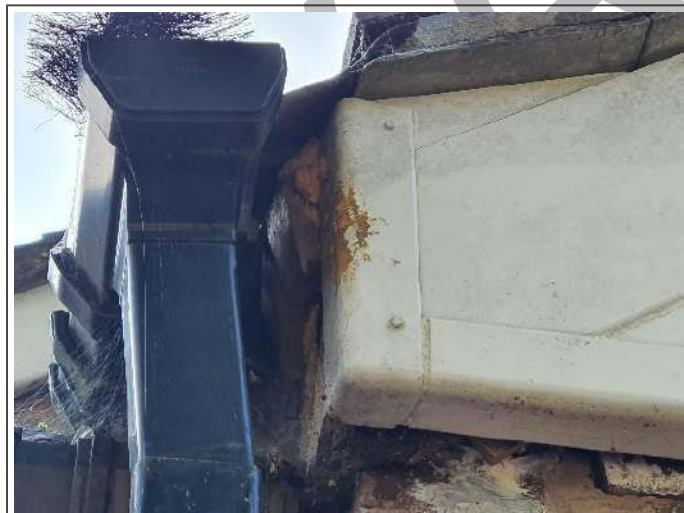
FRONT

CONDITION SUMMARY: Simply cladding with PVC is a sub-standard practice as this can actually cause timber to deteriorate more rapidly. You should therefore be aware that some work to repair the timber beneath may soon be required. There appears to be a DIY repair to the fascia board to the left-hand side of the property and you may wish to have this tidied up by a reputable building contractor.

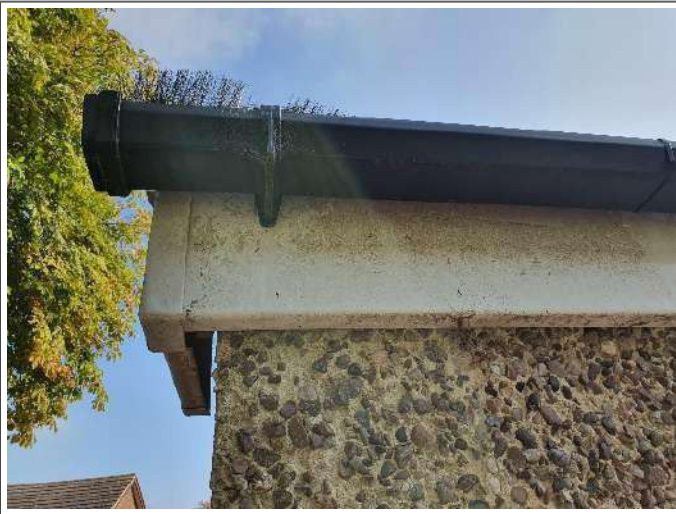
RIGHT

CONDITION SUMMARY: No significant defects were apparent to the joinery. However, as mentioned above, deterioration could continue beneath the PVC cladding.

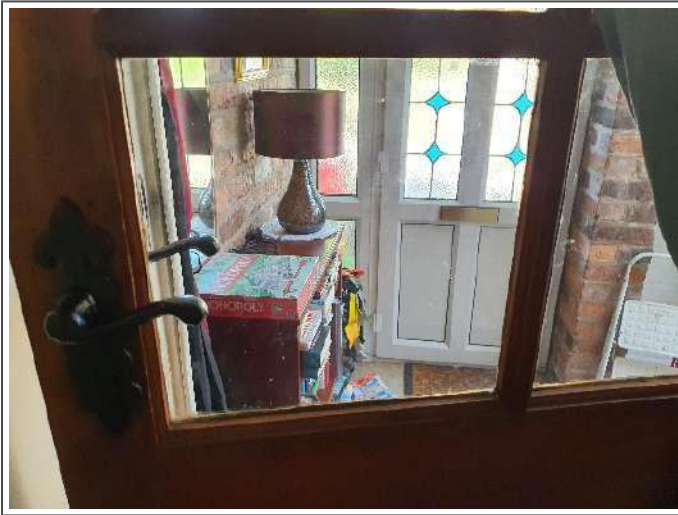
CONDITION SUMMARY: There is some glazing to the door that separates the porch from the kitchen; also, the kitchen from the lounge where no safety stamp was observed to indicate that safety glass has been used. Where there is no safety stamp, it is strongly recommended that an allowance is made for re-glazing in safety glass to prevent serious, or even fatal injury occurring from smashing the glazing.

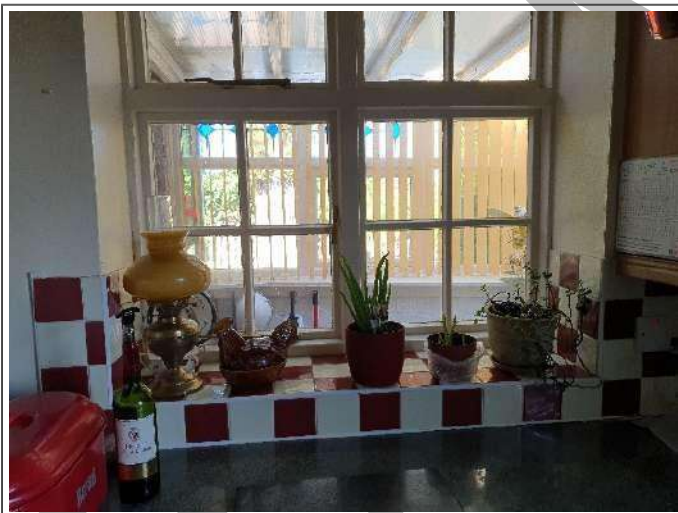
CONDITION SUMMARY: The handles to the windows are becoming loose and they will require attention/replacement soon. The Velux window in the shower room is likely to require maintenance or replacement soon. A closer inspection of the Velux should be carried out by the roofing contractor who installs the eaves tray as mentioned in the roof covering section.

CONDITION RATING: Defects that need repairing or replacing but are not considered to be either serious or urgent. The property must be maintained in the normal way.

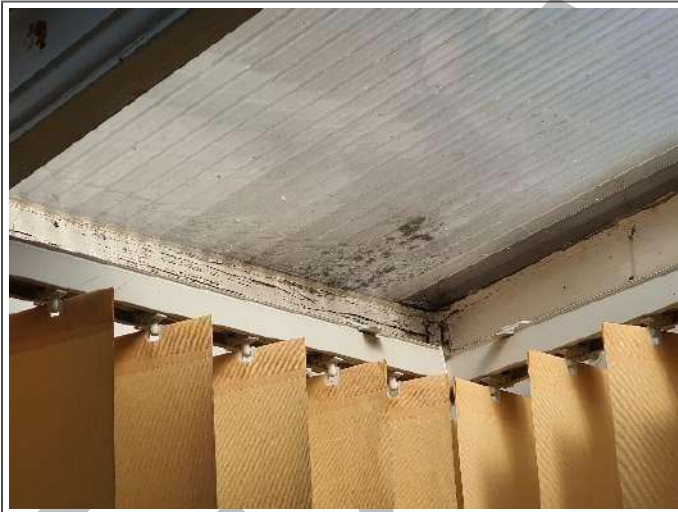
CONDITION SUMMARY: Some deterioration appears to be occurring to the wall plate of the front porch. This has probably been caused by condensation or excessive water not reaching the rainwater fittings externally. This should be discussed with the contractor who repairs the roof panels.

CONDITION RATING: Defects that are serious and/or need to be repaired, replaced or investigated urgently.

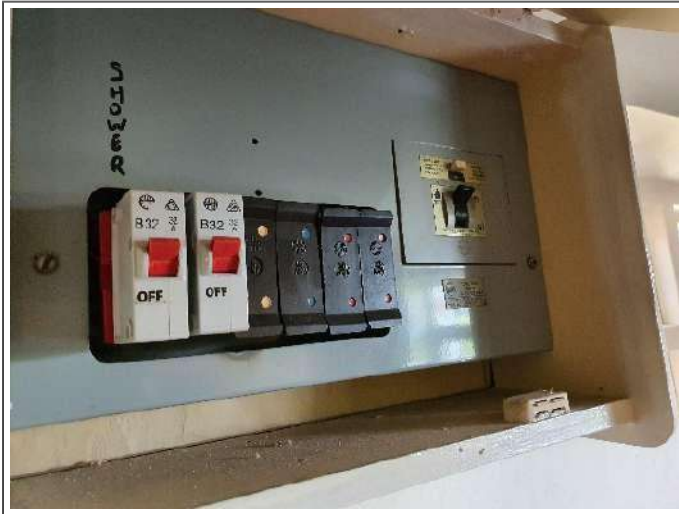
CONDITION SUMMARY: There is an old rewirable type fuse board still in place in the kitchen. This is considered to be a Health and Safety risk. An Electrical Installation Condition Report should therefore be obtained from a qualified electrical contractor and all recommendations implemented.

CONDITION RATING: Defects that are serious and/or need to be repaired, replaced or investigated urgently.

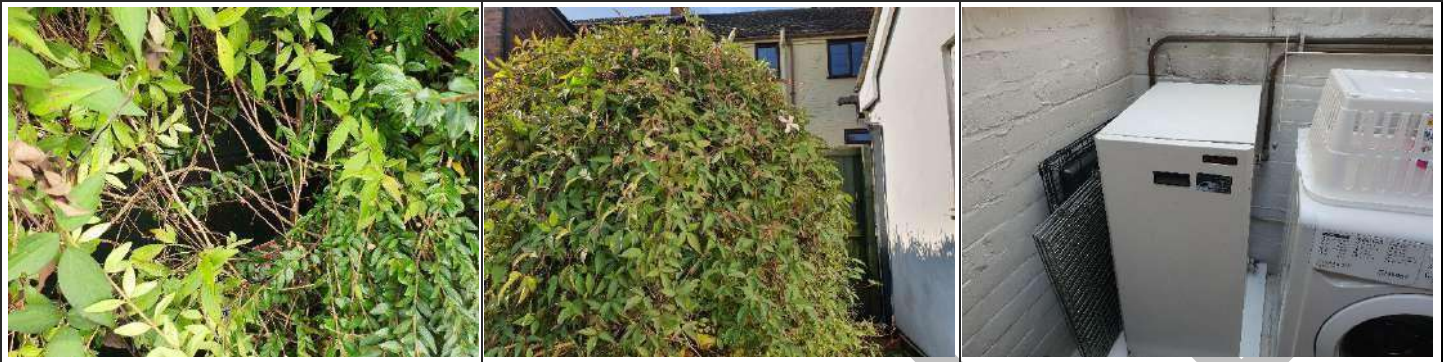
CONDITION SUMMARY: The oil tank is located in the grounds to the rear. The location of the tank does not appear to be compliant with safety regulations. The tank is also covered by a large Vine. You should discuss this with an OFTEC registered engineer. The oil fired boiler is in the front porch and appears to be old full. The boiler could require replacing soon and they should be discussed with your Engineer.

CONDITION RATING: Defects that are serious and/or need to be repaired, replaced or investigated urgently.

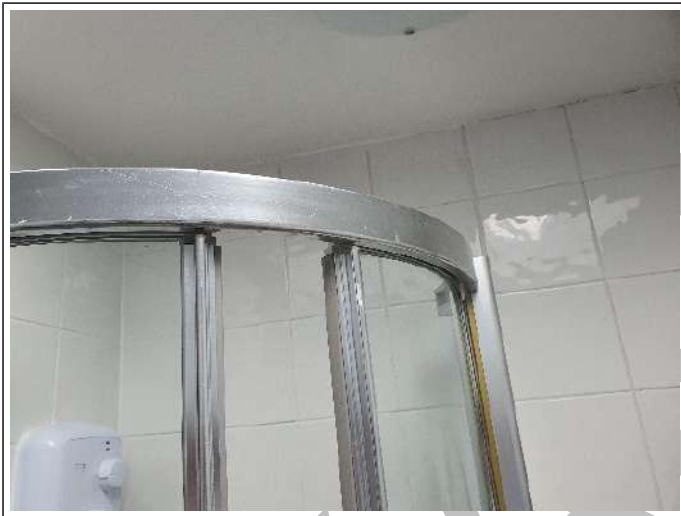
CONDITION SUMMARY: There is some black mould to the sealant around the shower. This type of mould can be toxic. There is no extractor fan for the shower room. Black mould occurs in spaces that have a lack of ventilation and high moisture content. You should therefore consider having an extractor fan installed that has a humidistat fitted to pull out excess moisture from the air. Opening windows when bathing and adding permanent ventilation to walls can also help reduce condensation and excess moisture. The sealant should be replaced with a mould resistant type. The shower screen is awkward and may require some attention soon. Some general wear and tear was also noted to the fittings generally.

CONDITION RATING: Defects that are serious and/or need to be repaired, replaced or investigated urgently.

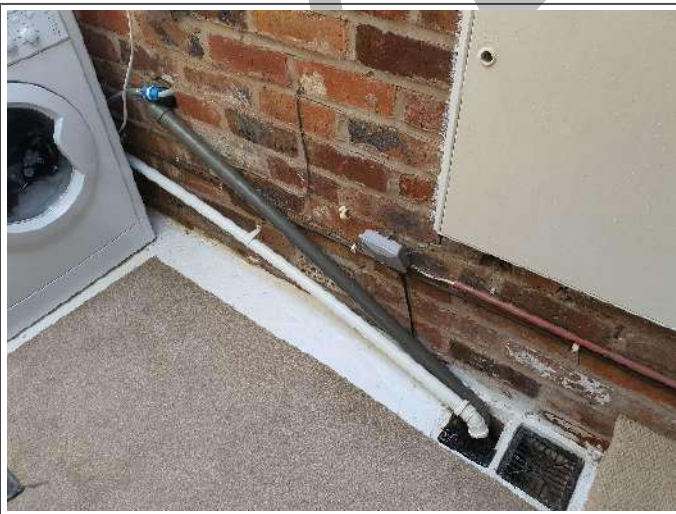
CONDITION SUMMARY: There are PVC grey water pipes that appear to be in a reasonable condition. The grey coloured pipe may require bracket to help prevent it from disfiguring.

CONDITION RATING: Defects that need repairing or replacing but are not considered to be either serious or urgent. The property must be maintained in the normal way.

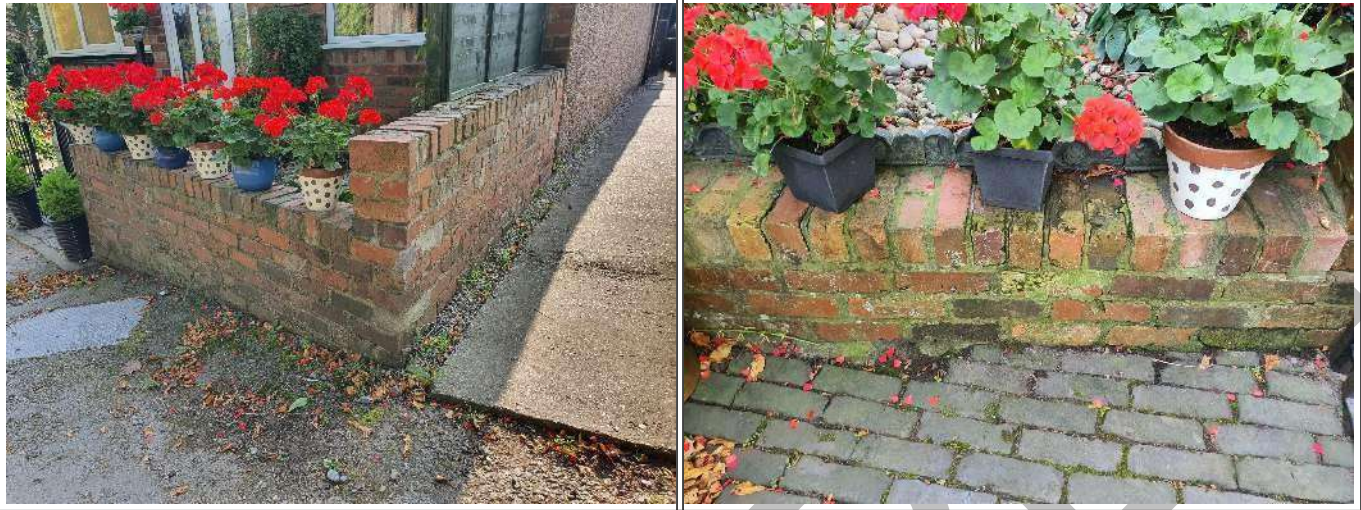
CONDITION SUMMARY: The brick wall to the front of the property will require some general maintenance soon.

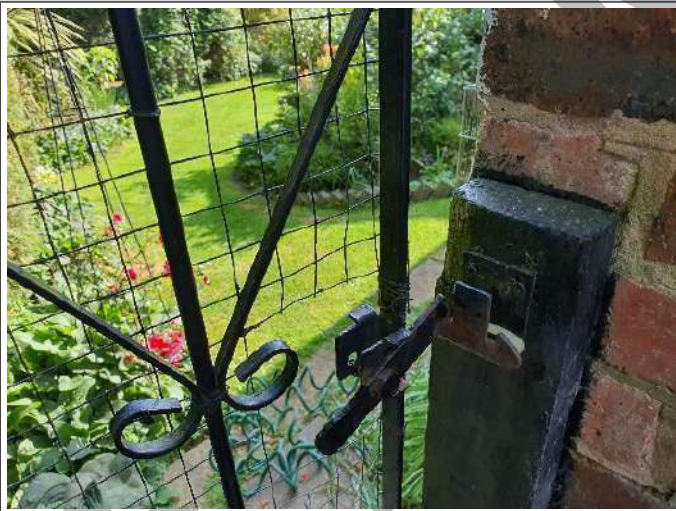
CONDITION SUMMARY: There are metal gates to the front/side that require redecoration to help prevent further corrosion. Some other maintenance is also required to help the gate operate correctly. The timber gate to the driveway also requires some attention and maintenance.

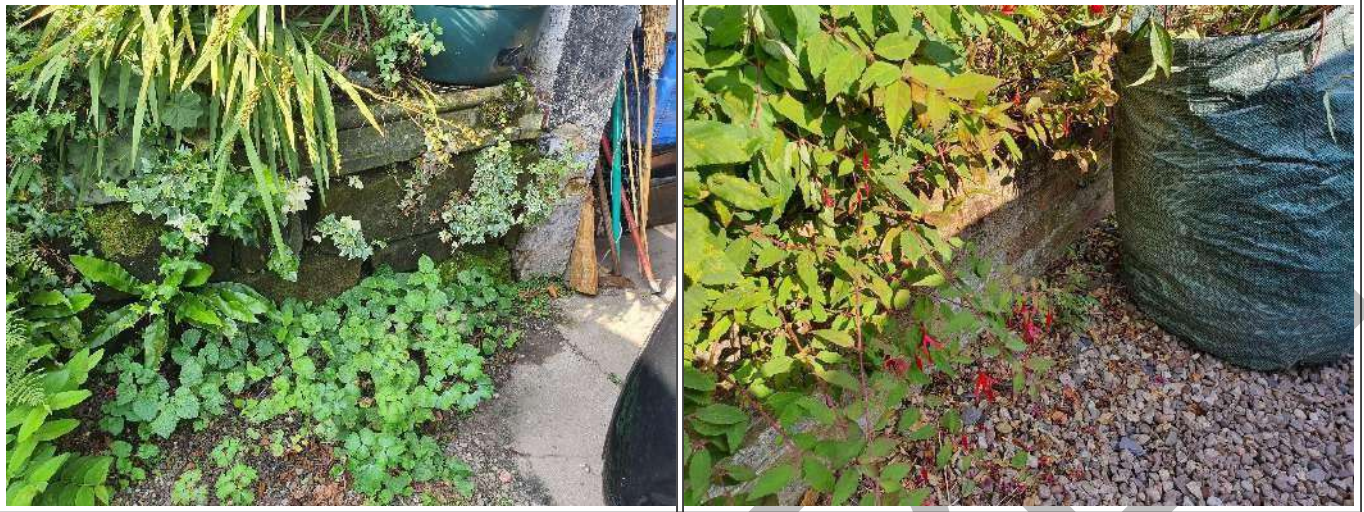
CONDITION SUMMARY: There are retaining walls to the rear and to the side of the driveway that appear to be single skin masonry. The walls are beginning to lean in places/there are cracks beginning to appear. Therefore, some or complete reconstruction could be necessary in the near future. Collapsing retaining walls can cause injury. Retaining walls should be at least two skins of masonry thick and have adequate foundations to help support the weight of the earth behind. Weep holes should also be installed with gravel behind to aid drainage and prevent the masonry deteriorating.

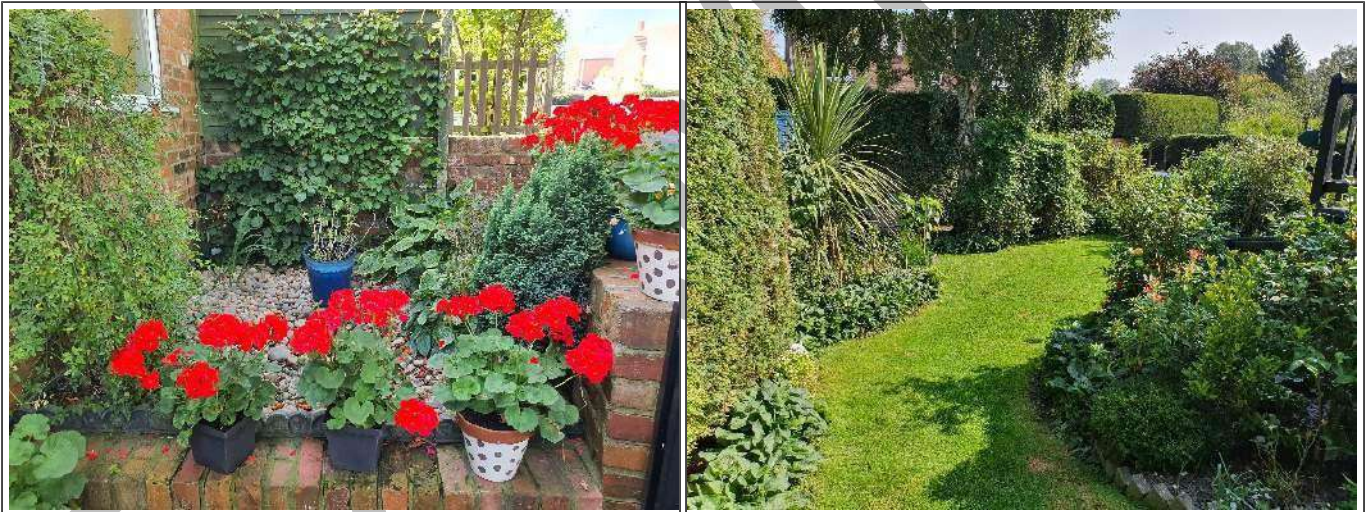
CONDITION SUMMARY: There are plants in garden and not all could be identified. View of the ground was also restricted. We did not observe any Japanese Knotweed at the time of the inspection. The plant could appear after you have bought the property as it can grow up to 10cm per day. Japanese Knotweed is becoming a problem in the UK as there is a perceived risk to buildings and the plant is very difficult to control. Recently, we have noticed a significant increase in findings of Japanese Knotweed. The presence of this plant can prevent mortgages from being accepted and this can have a significant negative impact on the value of your property. We are not experts in this field, and we recommend that you contact a specialist to carry out an investigation of the site and surrounding area. An area up to 7 metres beyond the boundaries should be checked as the roots can spread this far. You should also discuss indemnity insurance with your legal advisors to cover you against potential future losses should the plant ever affect the property.
