RICS Home Surveys

# Survey level two: HomeBuyer report – Survey and Valuation

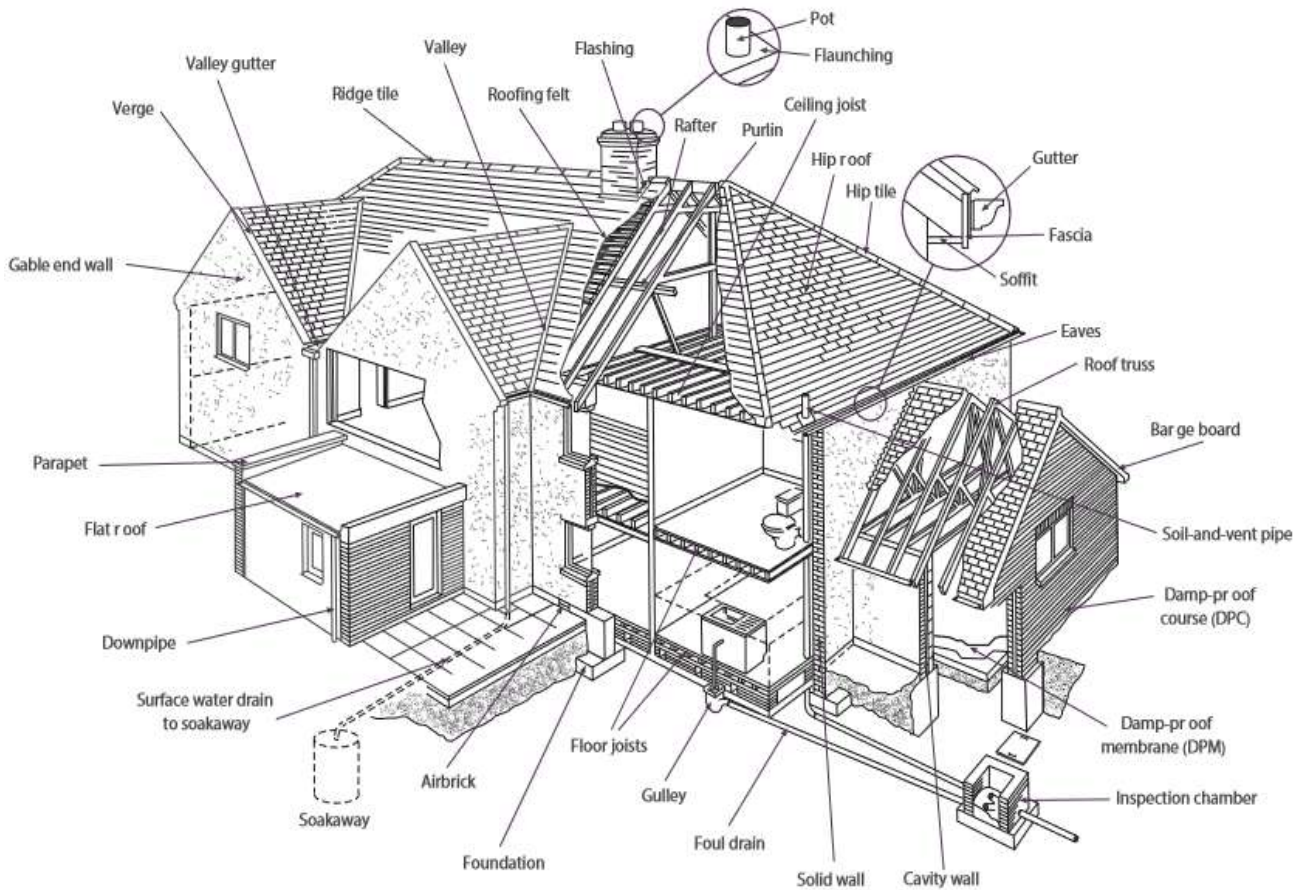
# Typical house diagram

This diagram illustrates where you may find some of the building elements referred to in the report.
